**AGREEMENT NO. RMC 17011 - COUNTY OF LOS ANGELES – PARKWAY BASIN
WATER QUALITY IMPROVEMENT PROJECT
TASK 6 - MONITORING AND ASSESSMENT PLAN AND COMPLETION REPORT**

From Attachment B - Final Summary Report (18-Month Anniversary of Construction)

Subject: Final Summary Report (18-Month Anniversary of Construction) for Infiltration Studies of Existing Low Impact Development Features, Parkway Basin Water Quality Improvement Project, Unincorporated Communities, Florence, West Whittier and Bassett, County of Los Angeles, California

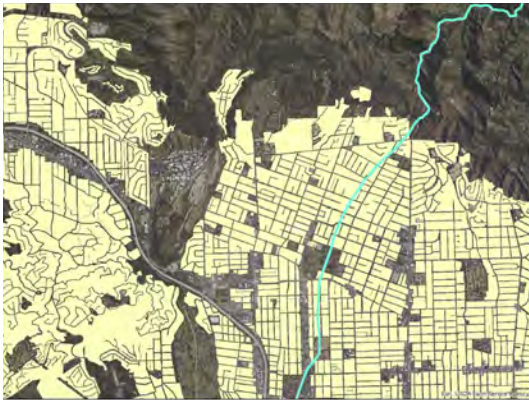
Altadena

Land Use

Data: Single-Family Residential categories as determined by the 2008 Southern California Association of Governments (SCAG) landuse dataset.

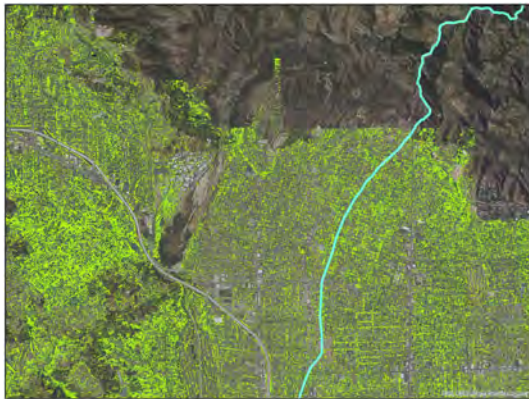
Altadena

Data: tree canopy as determined through the LA Region Imagery Acquisition Consortium (LARIAC) solar modeling based on 5-foot Digital Elevation Model (DEM) and Color Infrared (CIR) imagery at 4-inch resolution.

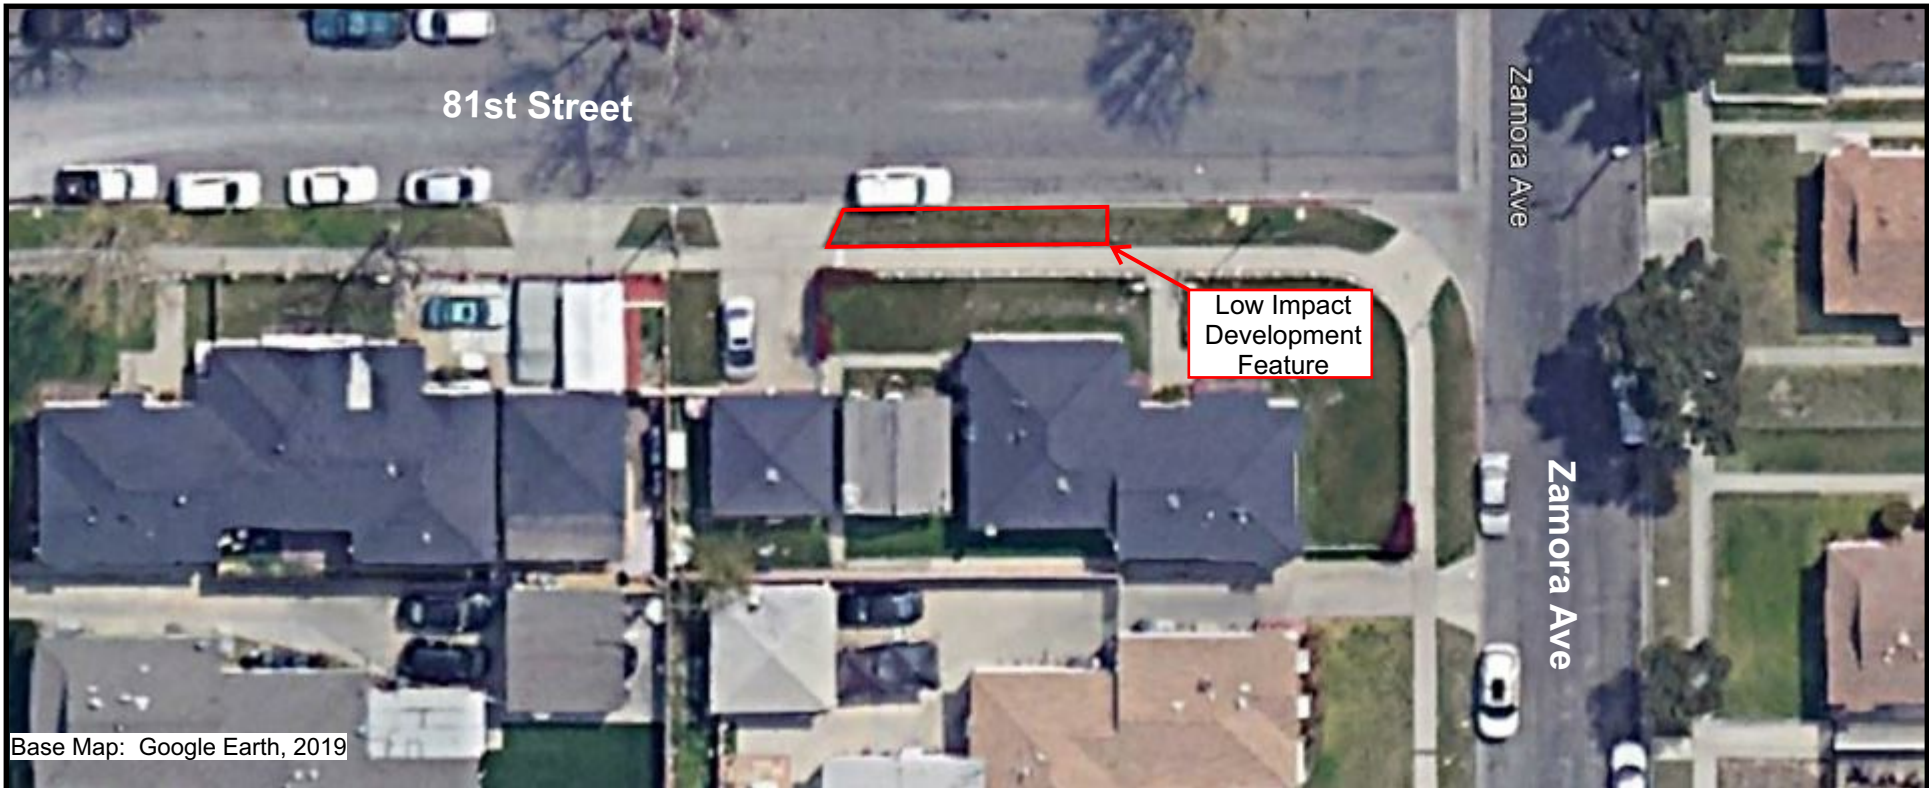
PETRA GEOSCIENCES™	DATE: September, 2020 J.N.: 19-278
Figure 1

An initial site reconnaissance was performed at each of the 4 predetermined LID locations (Figures 1 through 4) to evaluate the surrounding environment, photo document, record LID feature dimensions, and to document existing site conditions. Measurements of the LID feature dimensions are presented on

Figures 1 through 4 – Site Map. Current site conditions were also documented during the site reconnaissance and during testing. Descriptions of the observations are presented within Appendix A – Percolation Test Summaries and photos of the pre-testing conditions and as-tested conditions are presented in Appendix B – Site Photographs.

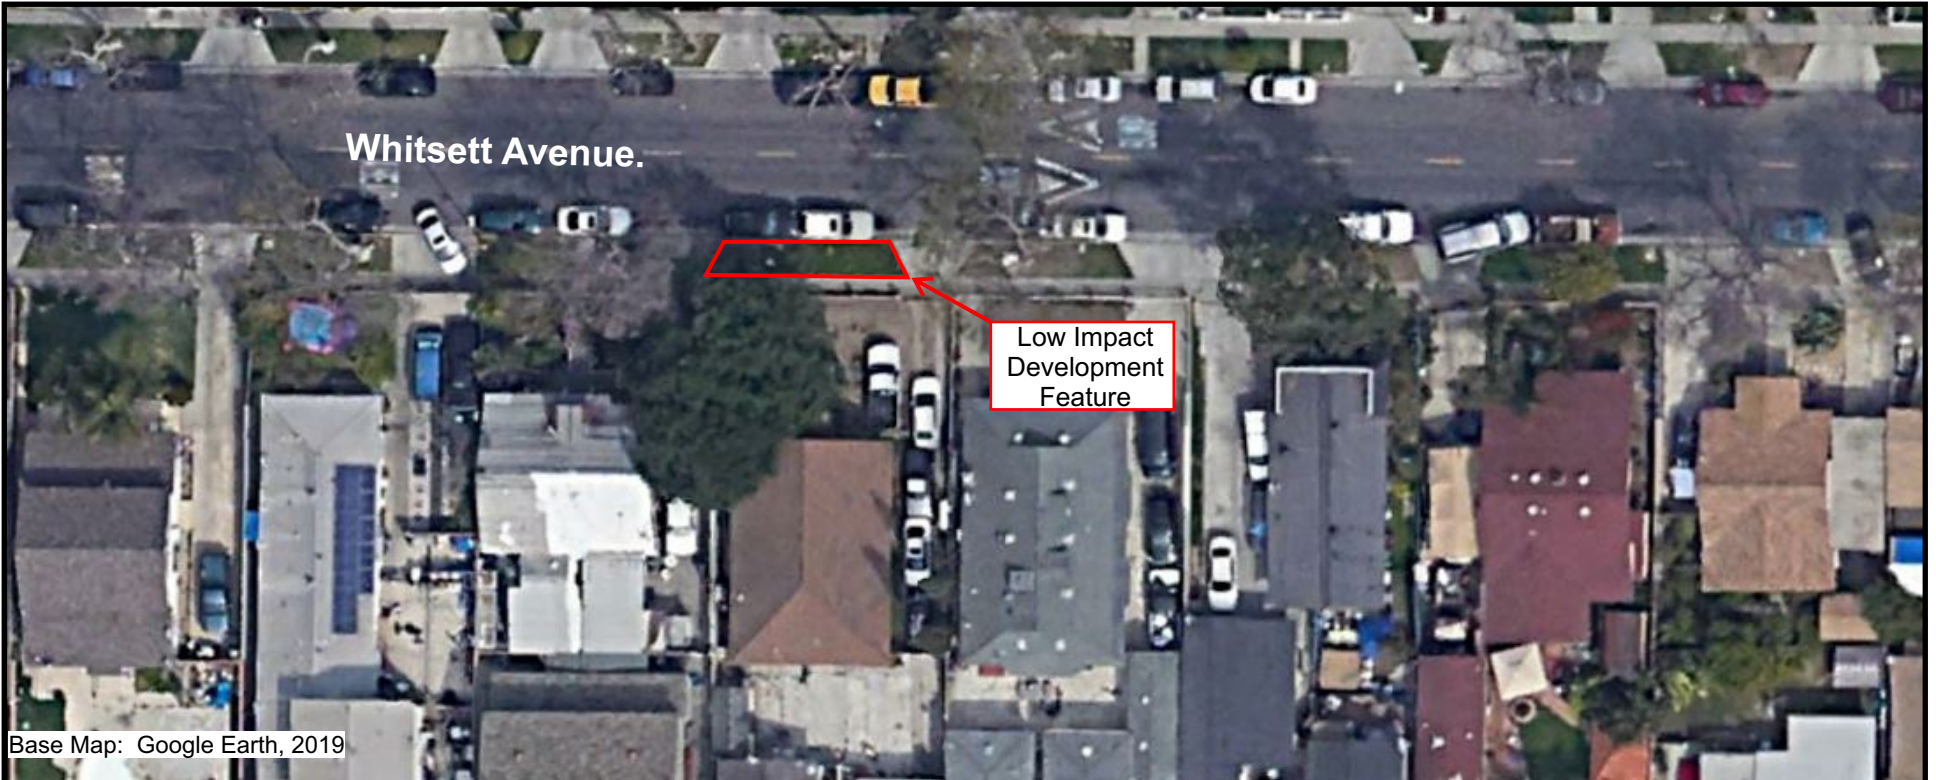
PETRA GEOSCIENCES, INC. 3186 Airway Avenue, Suite K Costa Mesa, California 92626 PHONE: (714) 549-8921 COSTA MESA TEMECULA VALENCIA PALM DESERT CORONA	
SITE MAP	
7319 Whitsett Ave. Los Angeles, California	
	DATE: September, 2020 J.N.: 19-278
Figure 2

Direction of gutter flow →

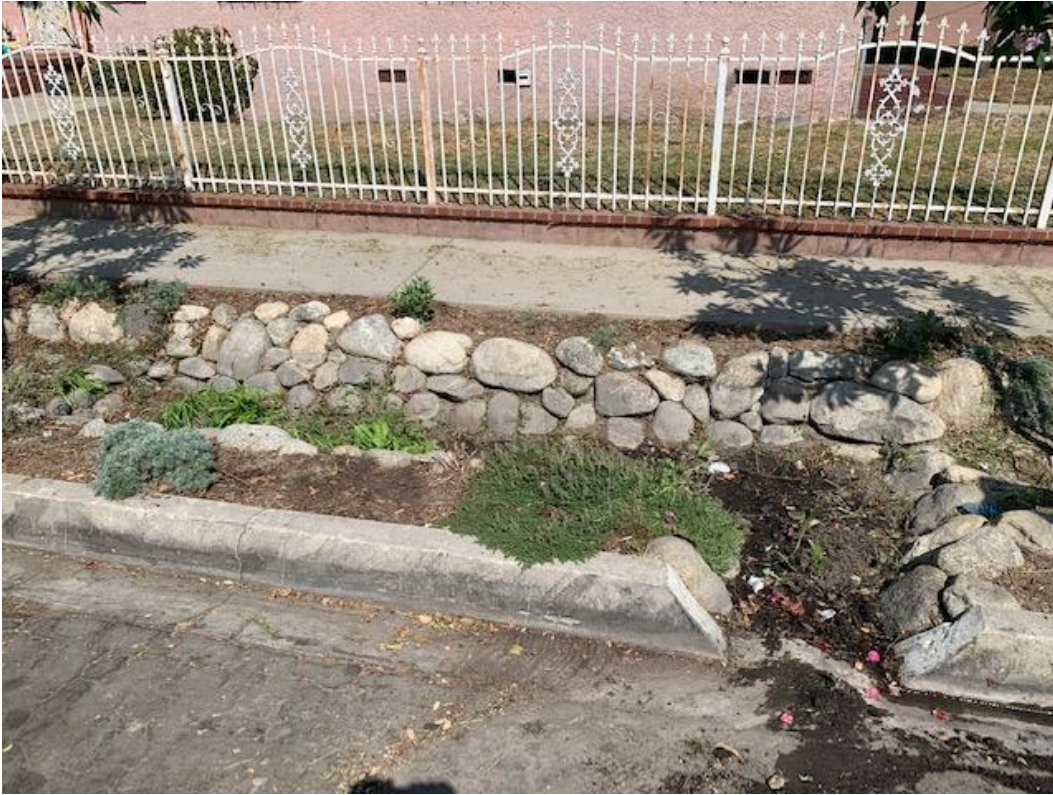
1405 East 81st Street, Los Angeles

Organic debris (generally leaves) with a few pieces of garbage was noted within the LID basin. Debris generally consisted of small plastic and cigarettes.

LID Feature condition prior to testing

Conditions within the LID features were found to vary seasonally and from site to site. All features accumulated an abundant number of decomposing organics (leaves, sticks, etc.) from 1 to 3 inches thick. Depending on the thickness and freshness, the organics may have created an impermeable boundary that would slow the infiltration of water. A small amount of plastic and paper debris also found their way into the features but impacted the infiltration capacity of the features much less due to the relatively small quantity of them. Increased maintenance would be recommended to remove unwanted debris and increase infiltration potential of each LID feature.

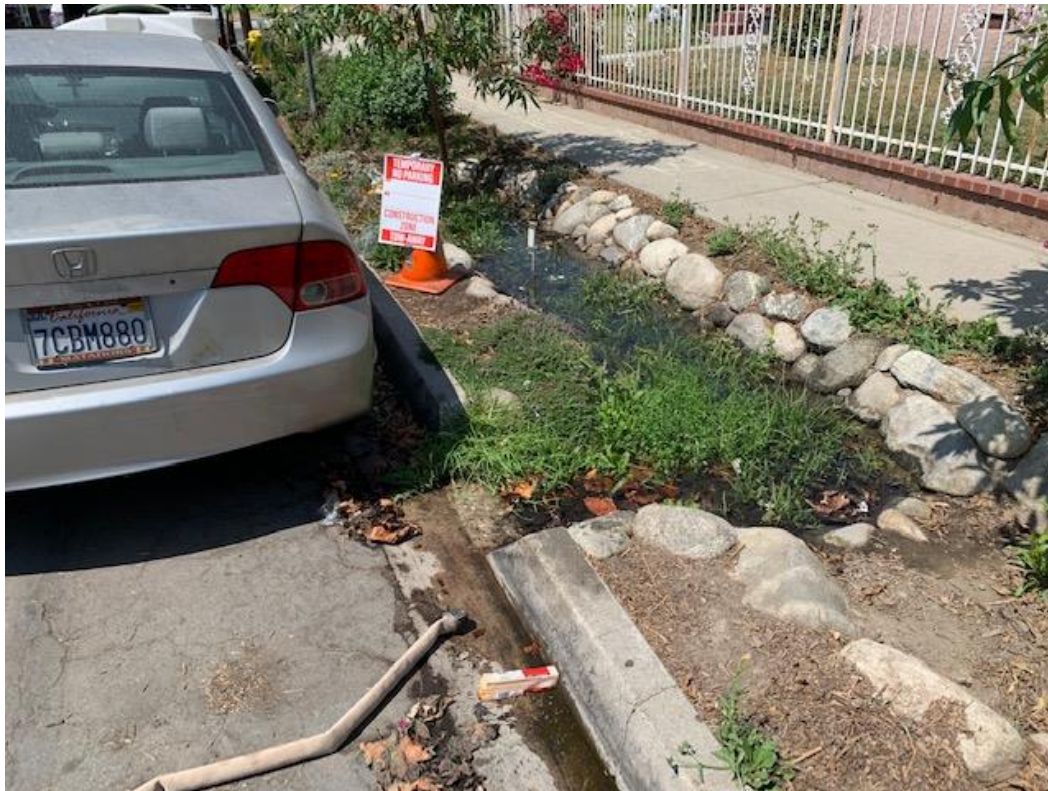
LID Feature during testing

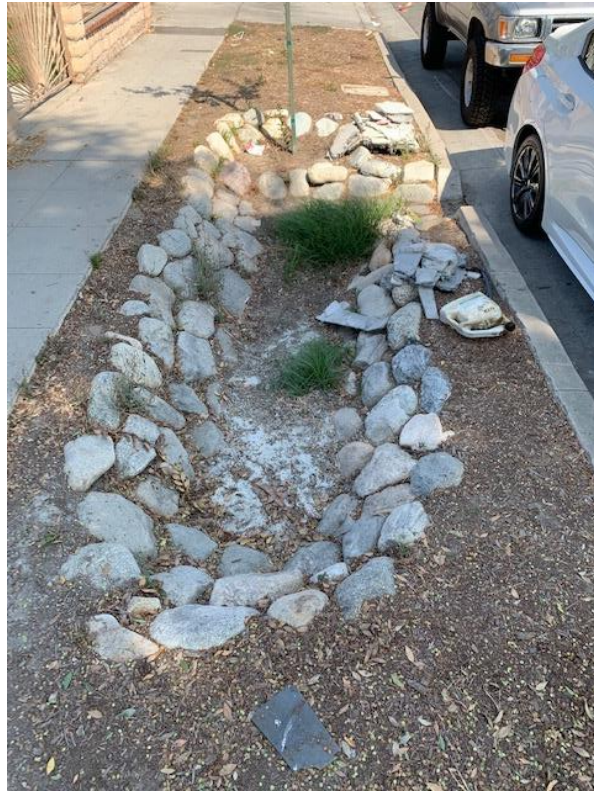
7319 Whitsett Avenue, Los Angeles

Condition of LID Feature:
 Light cover of organic debris, generally trace with a few areas up to 1" thick. No trash debris observed.

LID Feature condition prior to testing

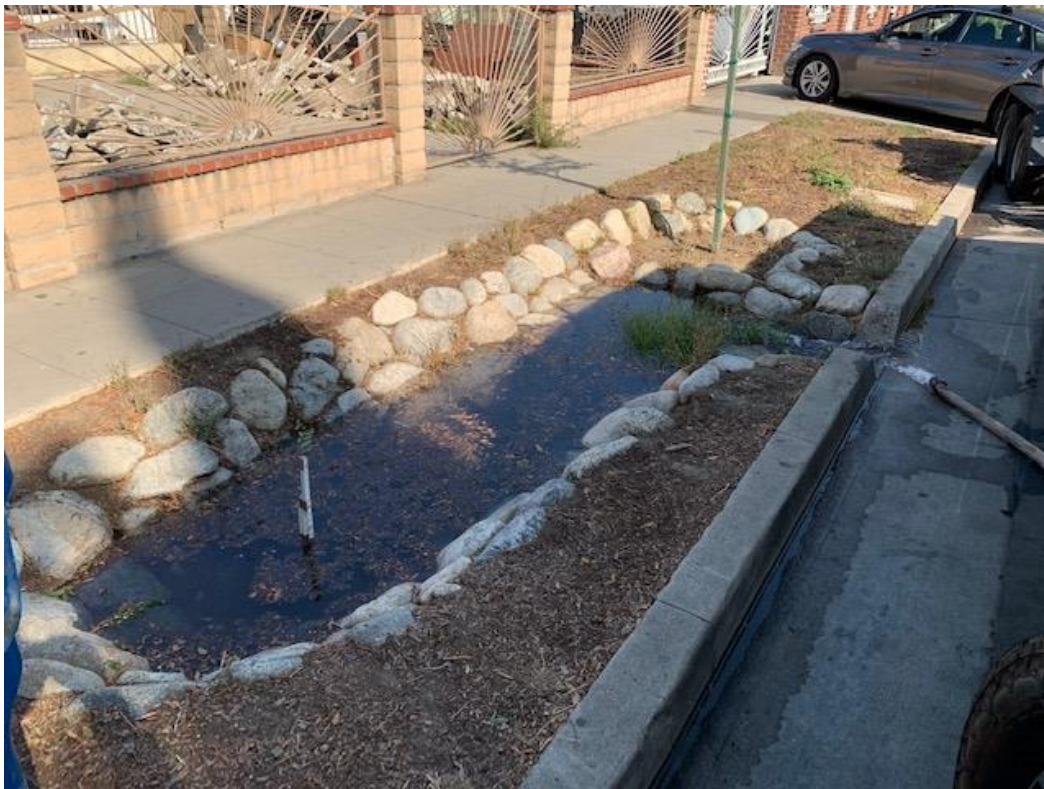
LID Feature during testing

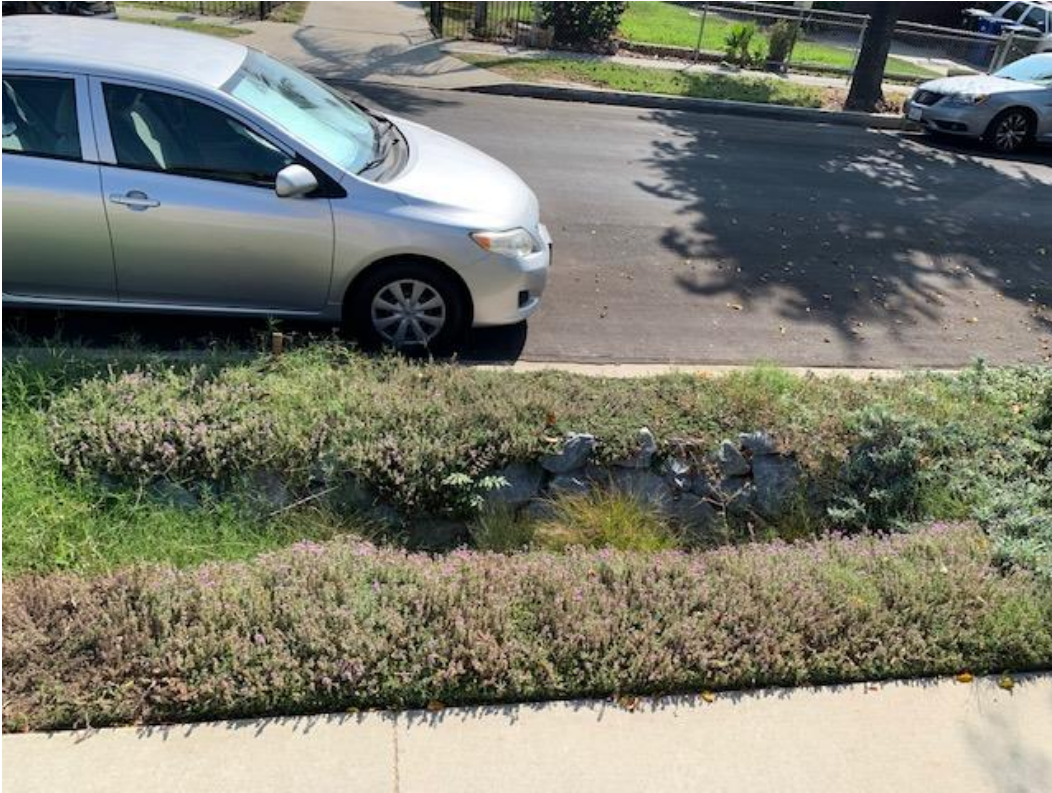
8609 Fallon Avenue, Whittier

Light cover of organic debris and weeds, with minor trash debris observed.

LID Feature condition prior to testing

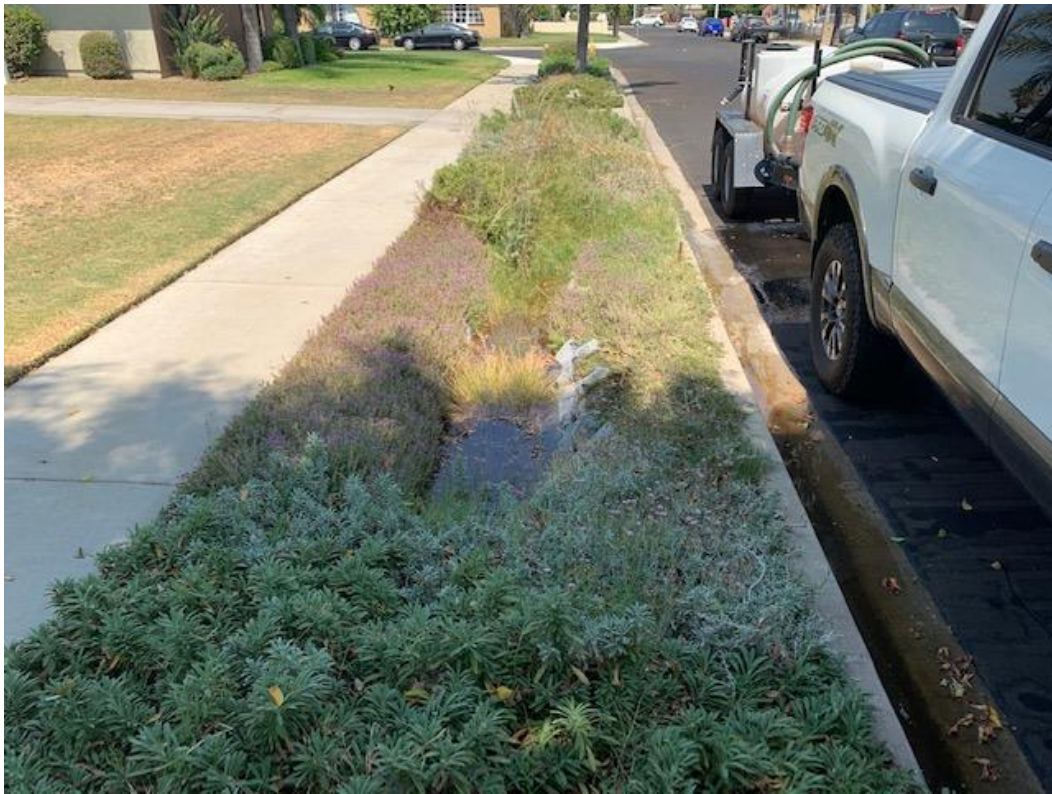
LID Feature during testing

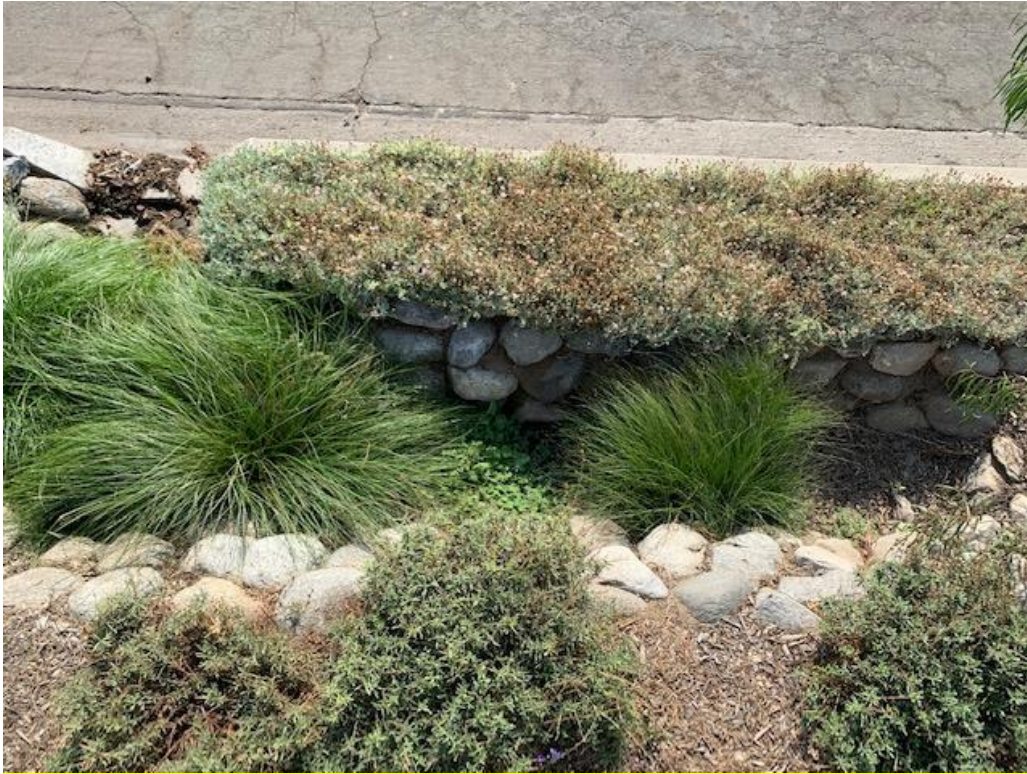
1143 Le Borgne Avenue, Bassett

Condition of LID Feature:
 Local resident was observed trimming and clearing LID basin. Basin was observed with trace debris and approximately 1-inch thick layer of organic material.

LID Feature condition prior to testing

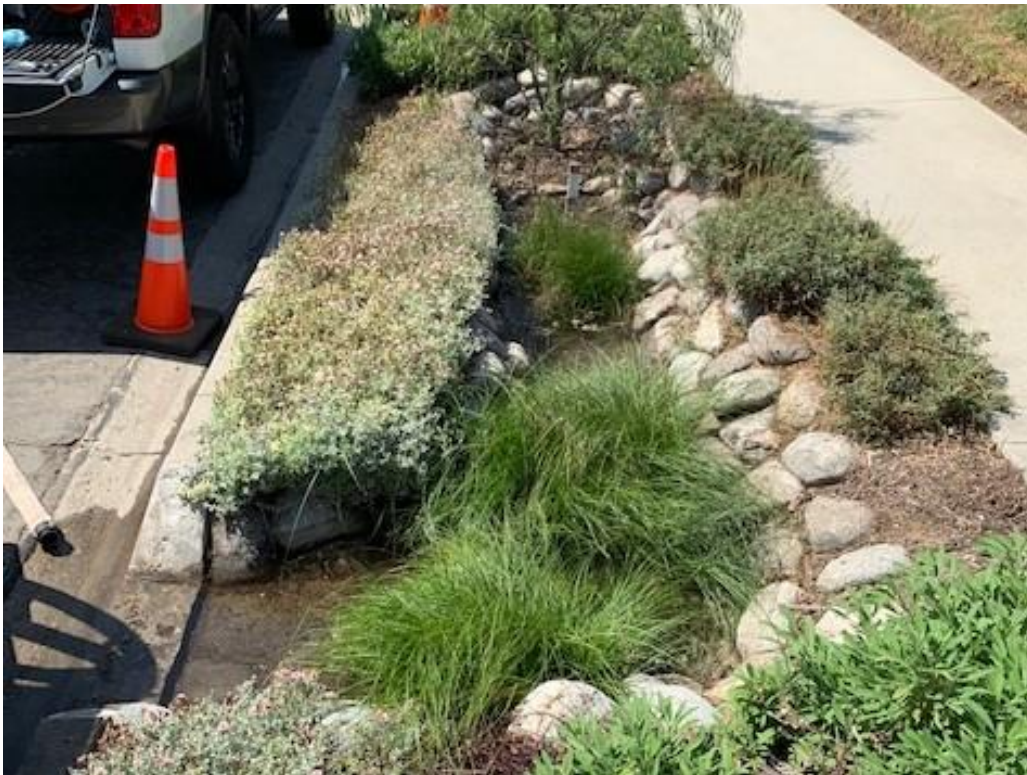
LID Feature during testing
